**2015 Monitoring Report  
Jones Road Landfill Site**

Part of Lots 1 and 2 Concession I,  
and Part of Lots 1 and 2, Concession II,  
Townships of Pettypiece and Jackman,  
District of Kenora

Prepared for:  
The City of Kenora

**Re: 2015 Report on the Monitoring Programs at the Jones Road Landfill Site**

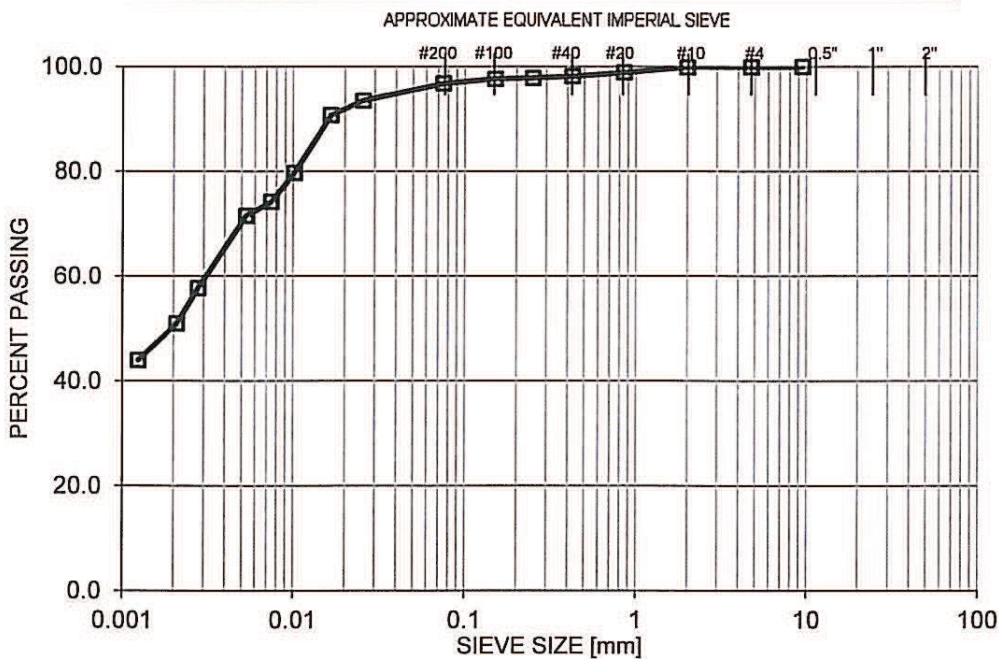
Test Hole No. TH2      Sample No. S2      Depth: 7.0 m  
 Sampled By: ENG-TECH      Type of Sample: Grab      Source: Project Site  
 Date Sampled: Jul 11/14      Date Received: Jul 14/14      Date Tested: Jul 16/14

SIEVE SIZE (mm)	PERCENT PASSING
9.500	100.0
4.750	99.9
2.000	99.9
0.850	98.9
0.425	98.2
0.250	97.8
0.150	97.6
0.075	96.8
0.026	93.5
0.017	90.7
0.0102	79.7
0.0074	74.2
0.0053	71.6
0.0028	57.7
0.0021	51.0
0.0012	44.0

Percent of: GRAVEL (0.1 %), SAND (3.2 %), SILT (46.3 %), CLAY (50.4 %)  
 Sample Description:
